Electrochemical Testing of Gas Tungsten Arc Welded and Reduced Pressure Electron Beam Welded Alloy 22

February 7, 2006

2006 ASME Pressure Vessels and Piping Conference
Vancouver, Canada
July 23, 2006 through July 27, 2006

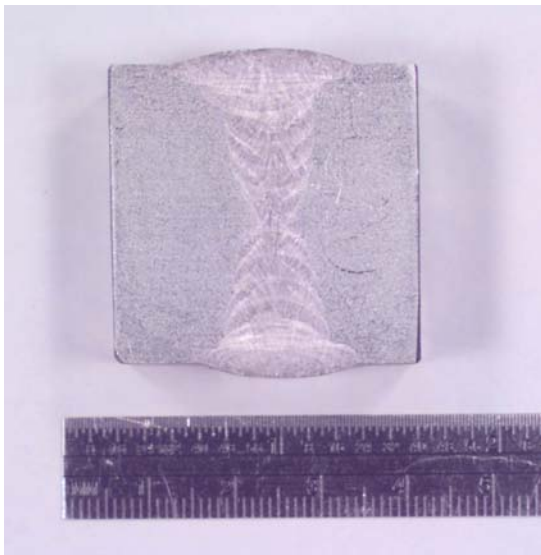
Figure 1 shows a macrograph of the cross section of a 1.5-inch thick Alloy 22 plate that was welded using the GTAW technique. This was a double V welding that consisted of at least nine passes on each side of the plate. Figure 1 shows that the width of the weld seam was up to 20 mm in the outside surface and approximately 10 mm wide in the middle section of each V (at one fourth of the plate thickness). Figure 2 shows a macrograph of the cross section of a 1.5-inch thick plate that was welded using the RPEB technique. This was a single pass autogenous weld, with a maximum width at the surface of 10 mm and a rather constant weld seam width through the

Figure 1. Macrograph of a GTAW welded Alloy 22 plate

thickness of the plate of 3 mm. Comparing Figures 1 and 2, it is obvious that the RPEB plate contains less amount of weld material than the GTAW plate.

Figures 17 and 18 show the macro appearance of the corroded RPEB and GTAW specimens after the galvanostatic tests for the 1 mA/cm² applied current density. Figures 17 and 18 show that both weld seams were preferentially etched. Figure 17 shows that the weld seam in the RPEB welded specimen was much narrower than the weld seam in the GTAW specimen (Figure 18). This agrees with the macro-etch appearances of the cross section of the weld (Figures 1 and 2).

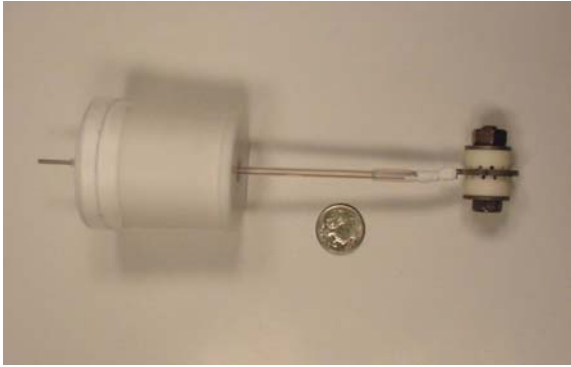
Most of the test specimens were discs designed to test for general corrosion and passivity according to ASTM G 5 guidelines. The MCA specimens were assembled using a Teflon-coated ceramic washer for crevice forming as described in ASTM G 48 [5] (Figure 3). The tested surface area of the disc specimens was approximately 0.7 cm² and the exposed MCA specimen area was about 5.6 cm². The test specimens were given a 600 grit silicon carbide abrasive paper finish approximately one hour prior to testing. They were then ultrasonicated in distilled water for 5 minutes and then degreased with acetone, isopropyl alcohol, and distilled water.

Figure 3. MCA Specimen for Crevice Corrosion Testing

Lawrence Livermore National Laboratory (LLNL). There were two type of specimens, discs (per ASTM G 5) [5] and standard MCA (multiple crevice assembly) specimens. The discs were prepared from five cores taken through the weld plate from the beam or arc side to the opposite surface. Four discs were sliced from each core, one from the top surface (A) and one from the bottom surface (D), and two from locations one-third (B) and two-thirds (C) the distance between these surfaces. The specimens used in this study were from the top surface (A) and the one-third depth level (B) beneath it. The GTAW weld specimen series was designated GXXX and the RPEM weld series 15XXX. Separate Alloy 22 base metal disks in the mill-annealed (MA) condition that were not taken from this welded plates were labeled DEAXXXX. The MCA specimens lie in the plate plane with the weld seams cutting across the loop end, perpendicular to the stem direction (Figure 3). The MCA specimens were taken from the same sampling levels (A through D) as the disks.

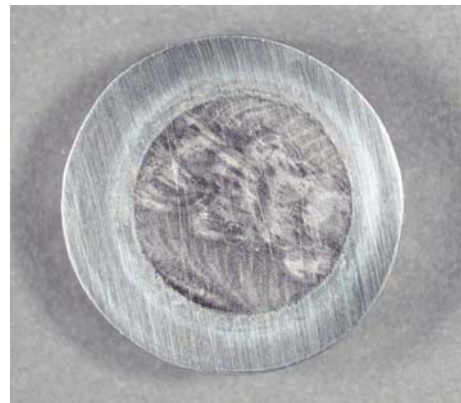
Figure 18. Specimen G03A (GTAW) after galvanostatic treatment of 1 mA/cm² for 3 h in 1 M HCl at 60°C
